Patrick McGuire
Owner, Wilcap Company

Starter Issues

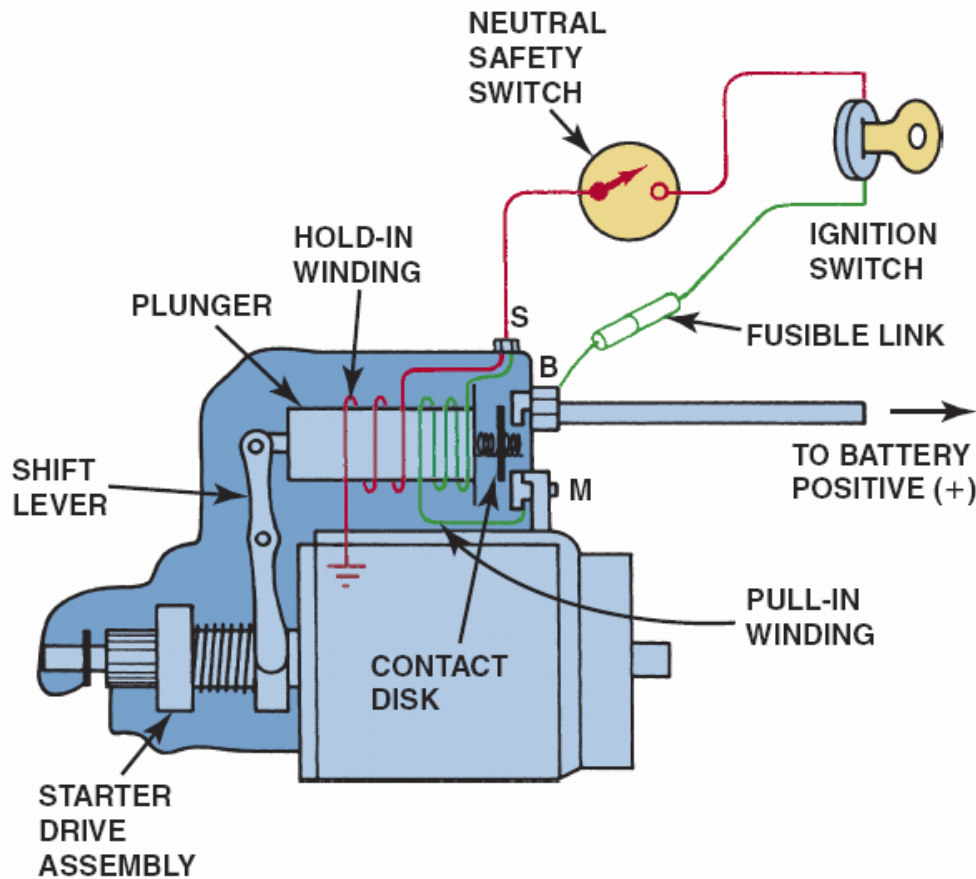
If voltage (really amperage) is too low then the motor turns for only a split second then the resulting voltage drop causes the hold in winding to weaken it's magnetic field and the plunger springs back to the starting point. The available voltage is high again for a split second then and the cycle starts all over. This is the familiar "clicking" of the starter motor with a dead battery.

The voltage can drop for any number of reasons so the first thing to check is of course the battery. A starter battery should be at 12.6 volts (12 volts is only 25% charged) and be able to take a load test or $\frac{1}{2}$ the cold cranking amps for 15 seconds without dropping below roughly 9.5 volts and should "bounce back" to 12.5 volts within 10 minutes.

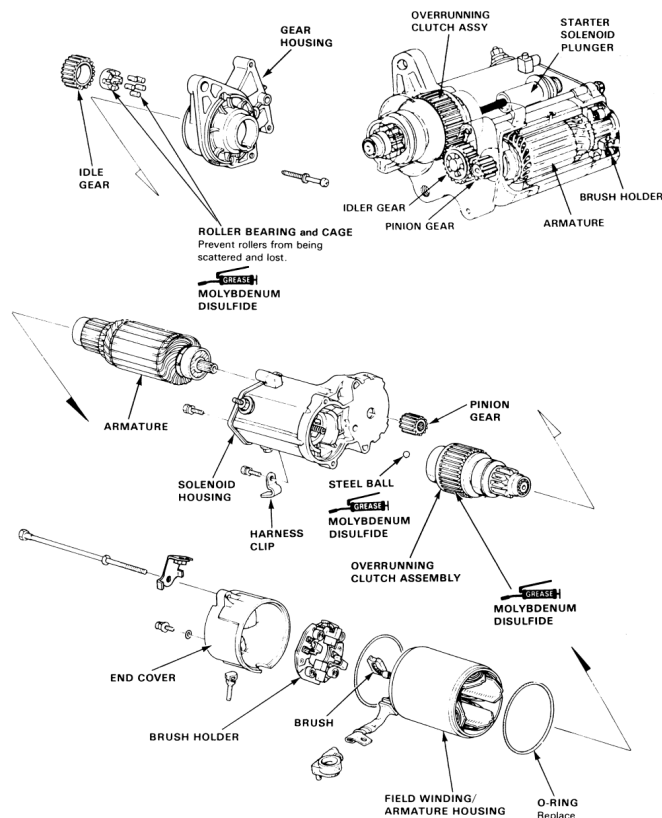
If all of this looks good then pull the starter to check for mechanical issues. The overrunning clutch should be stiff and only lock to the shaft in one direction only. The pinion can't have any chipped teeth and should have to be pried out against the solenoid plunger spring.

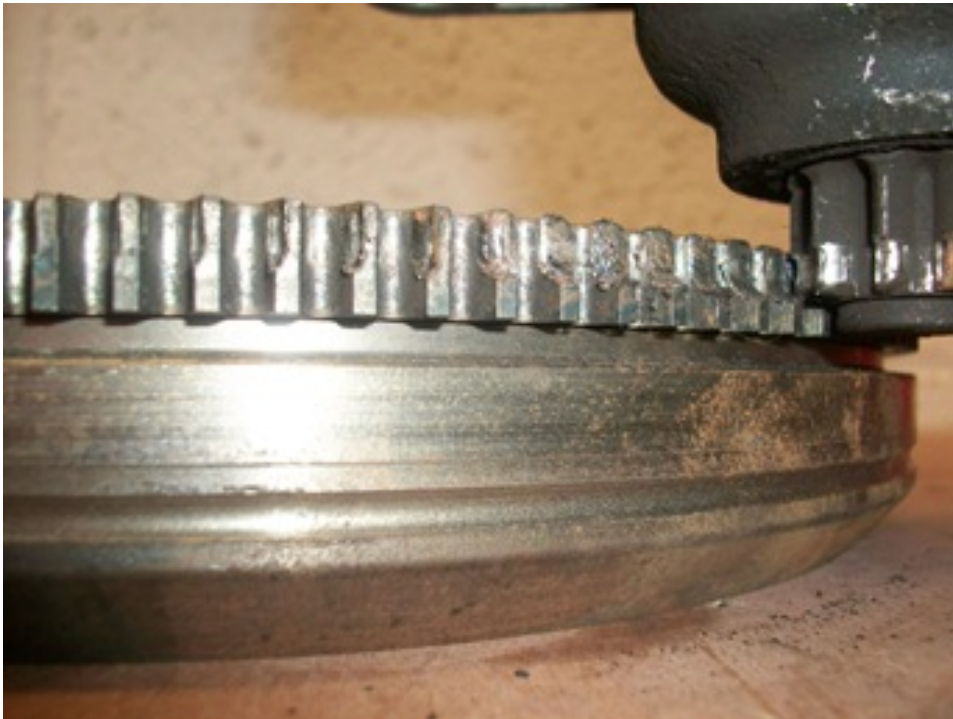
To keep that condition from happening the starter not only uses the overrunning clutch but also the solenoid return springs and the pinion gear is made with a slight taper to it so that clearance is least at the base of the gear. By design the pinion gear is not supposed to travel the full width of the ring gear. $\frac{1}{2}$ to $\frac{2}{3}$ is sufficient and keeps the pinion gear from “hanging” or sticking. If you are skeptical of this look closely at a worn ring gear and you will see that the wear that shows is about $\frac{1}{2}$ way across the face.
