Keeping Your

BY CHUCK EDDY

KEEPING YOUR HORSES IN LINE

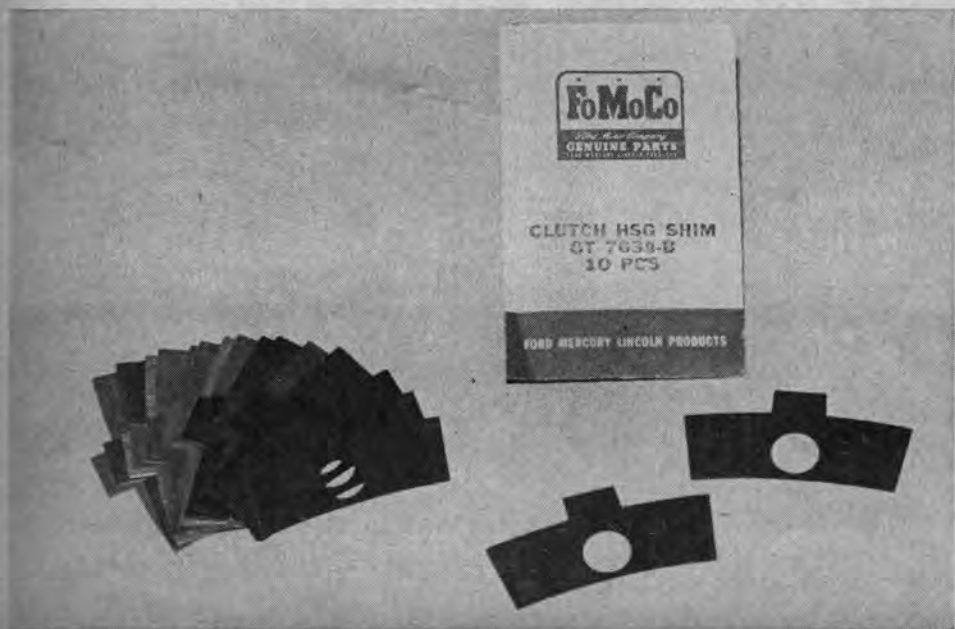
Alignment shims may be purchased from Ford dealers. Thicknesses run from .002 to .010.

Shims for this purpose may also be purchased through your local Ford dealer. The part numbers are 8T-7638 A, B and C. These are respectively (A) 2, (B) 3, and (C) 10 thousandths thick with the thickness stamped on a tab which protrudes outside the housing when properly installed.

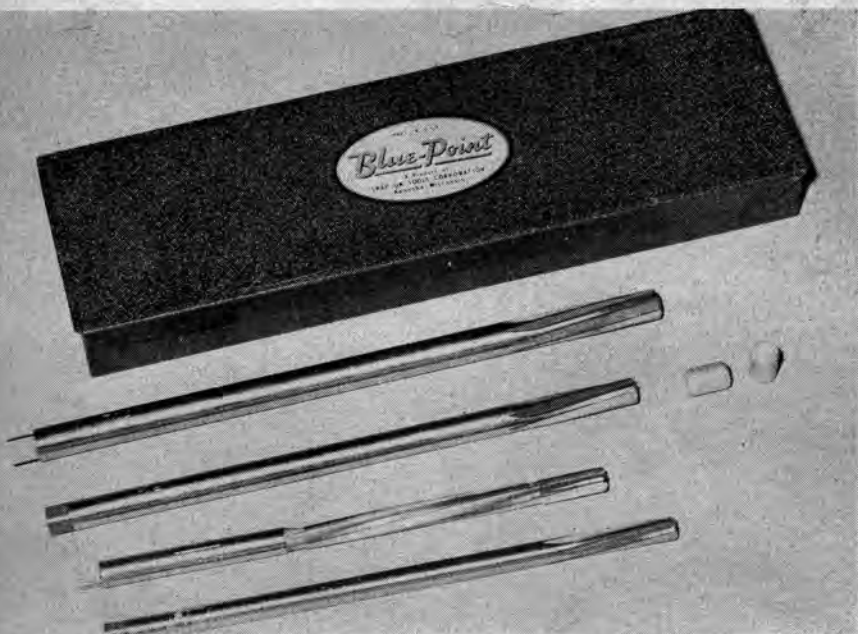
Oversize dowels may be installed, using special reamer set shown here. TREND BOOKS PHOTO
